Top Notch Home Inspections

Property Inspection Report

1989 N Lion Ave , Fresno , CA 93722
Inspection prepared for: Marty McFly
Real Estate Agent: John Smith -

Date of Inspection: 6/9/2023 Time: 9 am
Age of Home: 15 Years Size: 2,126 sqft

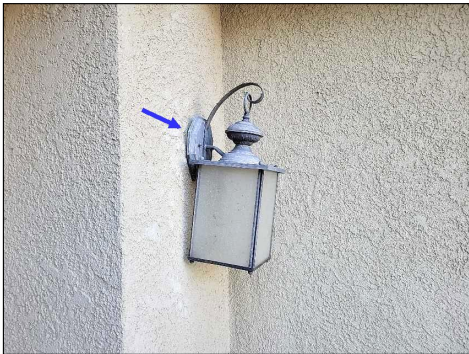
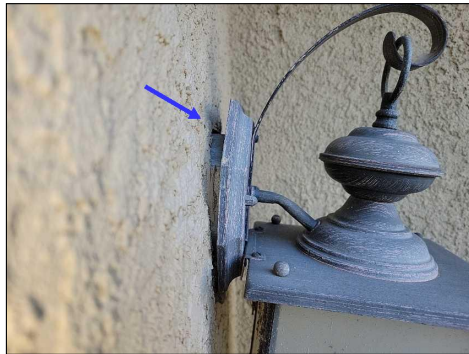
- There is a gap around the front carriage light fixture. This is an access point for moisture and pest to enter through. Tightening and caulk around suggested.
- The **GFC** outlet by the front door was observed as not working. The reset button is also missing. This is a defect. I recommend further review and repairs by an electrician.

Fixture separating from the wall (pic 1) Fixture separating from the wall (pic 2) Outlet does not work. Missing gfci tab

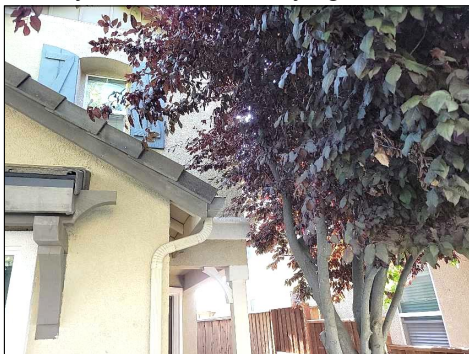
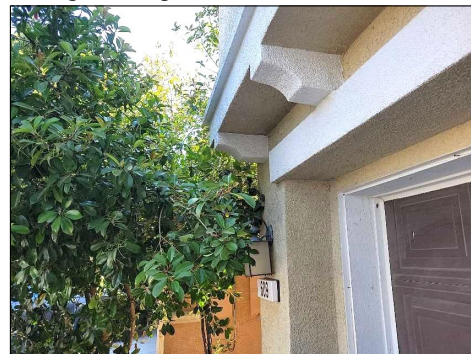
- There is vegetation in contact with the house.
- Maintenance Tip: When landscaping, keep plants, even at full growth, at least a foot (preferably 18 inches) from house siding and windows. Keep trees away from foundation and roof. Plants in contact or proximity to home can provide pathways for wood destroying insects, as well as abrade and damage siding, screens and roofs.

Vegetation in contact with the house.

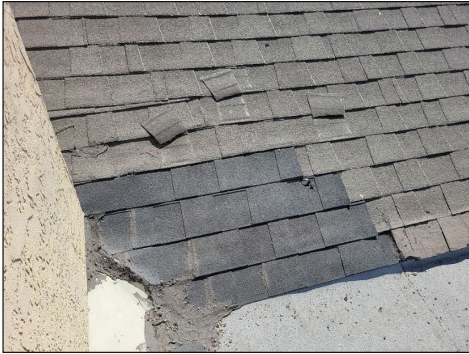
- Roof was mounted and walked on
- Asphalt shingles noted.
- **Damage was observed on the roof. I recommend follow-up by a licensed roofer for further evaluation.**

Roof damage

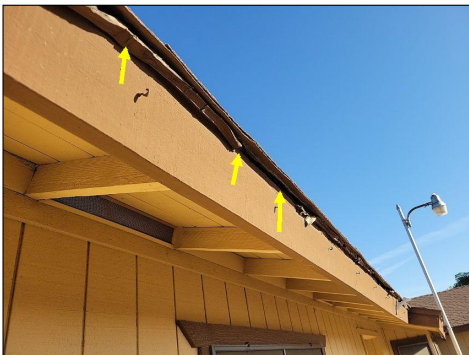
- Kick out flashing missing. This helps divert water away for the exterior. Without this flashing water damage will occur. I recommend further review by roofing contractor.
- **Partial installation of drip edge flashing was observed with wood damage. Flashing was missing at the back of the home. Drip edge flashing prevents moisture from getting under the roofing materials and decking. If moisture were to get under the roofing material, premature failure and other damage can occur. I recommend further evaluation for possible correction by a roofing contractor.**

Missing drip edge

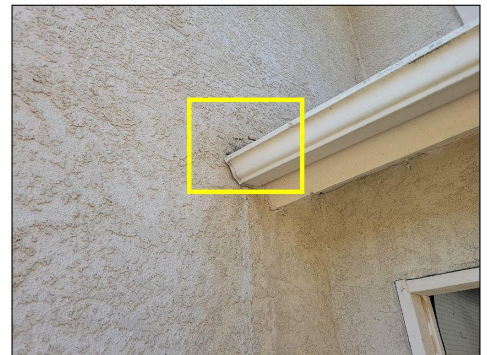
Missing kick out flashing

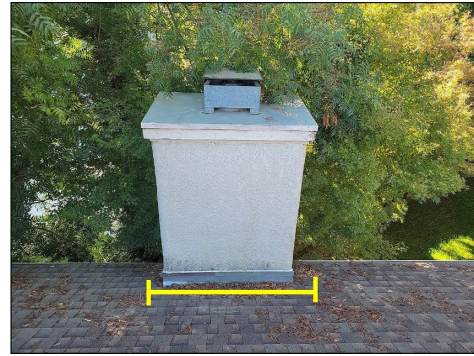
- Missing cricket. If the chimney has a dimension parallel to the ridge line greater than 30 inches and does not intersect the ridge line, a chimney cricket should be provided. I recommend further review by a roofer or chimney contractor.

No cricket flashing present

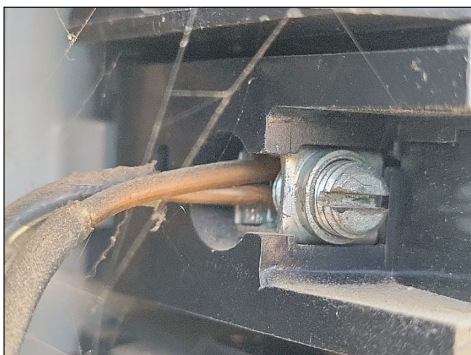
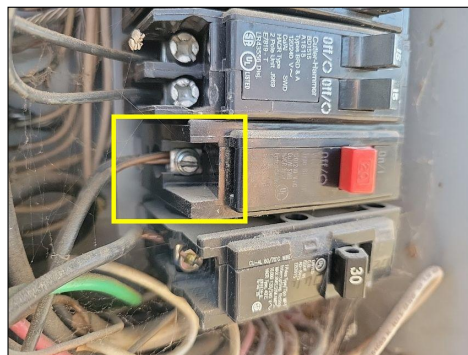
- **Double tapping observed. Double tapped breaker(s) inside panel box (more than one electrical conductor attached). This is not standard practice, and may cause overheating or even an electrical fire. Recommend review and repair as needed by a qualified electrician.**

Double tap wiring

Electrical Panel		
Page 12 Item: 3	Breakers & Wiring	• Double tapping observed. Double tapped breaker(s) inside panel box (more than one electrical conductor attached). This is not standard practice, and may cause overheating or even an electrical fire. Recommend review and repair as needed by a qualified electrician.
Heat/AC		
Page 13 Item: 1	HVAC Condition	• While running the AC an air leak was observed at the HVAC unit in the attic. Multiple types of tape were around the area indicating previous attempts at fixing an issue. I recommend further review by a HVAC contractor.
Living Rooms, Halls		
Page 18 Item: 13	Stairs & Handrail	• The hand rail is missing in the upper stair well of the home. This is a safety issue. I recommend further review by a contractor.

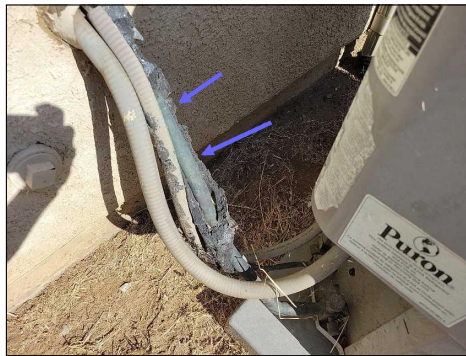
- HVAC is a split system
- Gas fired forced hot air.
- Electric
- AC compressor is located in the back yard
- Furnace is located in the attic
- At the AC condenser. The insulation cover around the refrigerant line is deteriorating and no longer useful. I suggest replacing to prevent higher cost for running the HVAC.
- Carrier Model # 24ABB342A300, 3.5 tonnage unit
- Maintenance Tip: Recommend that HVAC professional seasonally check the air conditioning unit.
- Rodent dropping were observed on the furnace in the attic. I suggest further review by a rodent inspector.
- While running the AC an air leak was observed at the HVAC unit in the attic. Multiple types of tape were around the area indicating previous attempts at fixing an issue. I recommend further review by a HVAC contractor.

Torn insulation cover

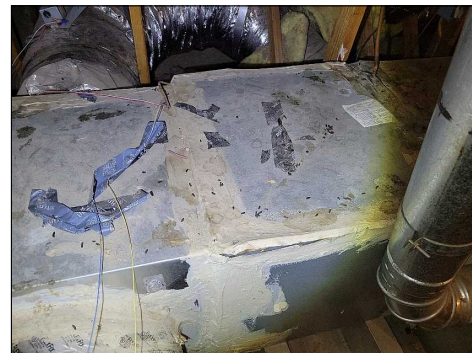
Rodent droppings

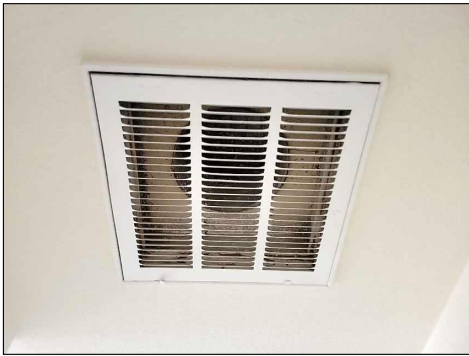
- Located in a filter grill in the hall ceiling
- The filter is missing at the return air supply grill.
- Running the HVAC system without a filter can cause damage to the system. Recommend placing a filter to prevent damage.
- **MAINTENANCE:** The air filter(s) should be inspected at least monthly and cleaned or replaced as required. There are two types of filters commonly used: (1) Washable filters, (constructed of aluminum mesh, foam, or reinforced fibers) these may be cleaned by soaking in mild detergent and rinsing with water. Or (2) Fiberglass disposable filters that must be REPLACED before they become clogged. Remember that dirty filters are the most common cause of inadequate heating or cooling performance.

Filter is missing

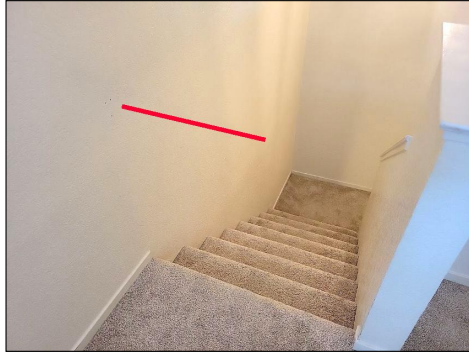
- The hand rail is missing in the upper stair well of the home. This is a safety issue. I recommend further review by a contractor.

Missing handrail

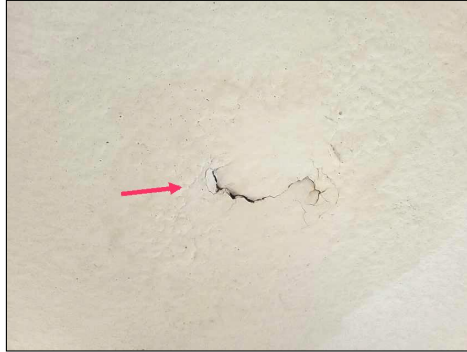
- Textured painted ceiling noted
- Evidence of past water damage with a hole was observed by the ceiling fan. Using thermal imaging, no moisture was detected at the time of inspection. I recommend further review with repairs by a contractor.

Past water damaged to ceiling in flex room

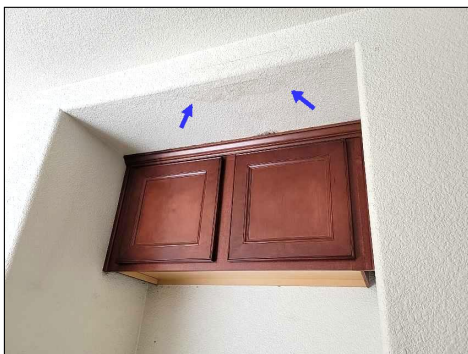
- Past water damage was present to the ceiling over the refrigerator area. The primary bathroom and shower area is directly above. Using thermal imaging, no moisture was detected at the time. Monitor for any changes.
- **Fungal growth was observed at the cabinets over the refrigerator area. I recommend further review by a contractor.**

Past water damage

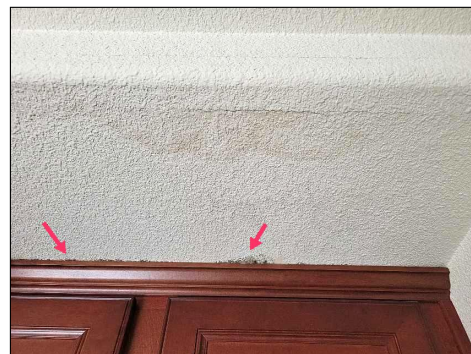
Fungal growth

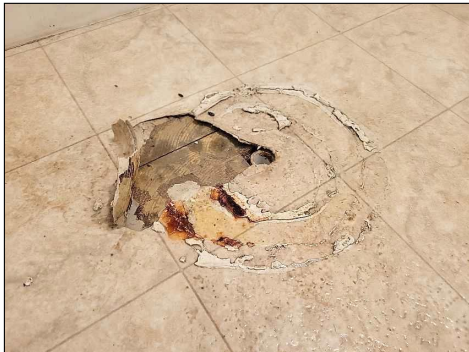
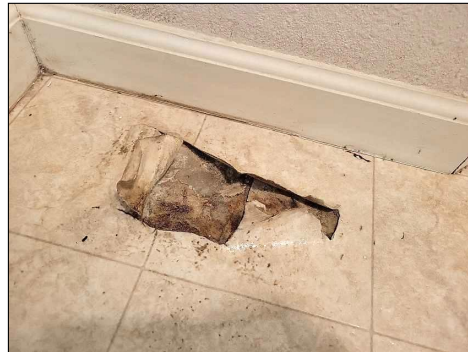
- Sheet vinyl flooring is noted.
- **Damage was observed to the flooring.**

Damage to flooring

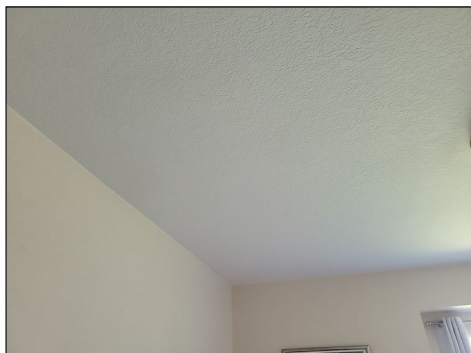
- Textured painted ceiling noted
- A heat anomaly was observed at bedroom #3 ceiling. This area is not accessible in the attic space. I was unable to locate the source of the heat. No moisture was detected. I suggest monitoring this area for any changes and contact a contractor if needed.

Heat anomaly

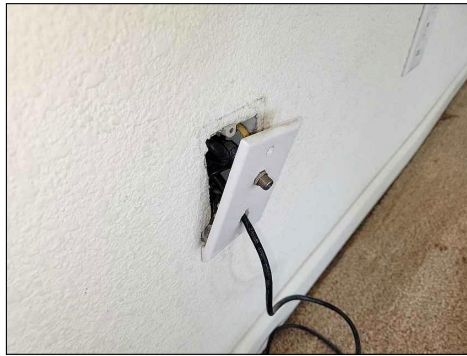
- Electrical appears to be functional and in good condition at time of inspection.
- The cable outlet was loose. I suggest re securing to prevent loss of energy in the wall space.

Cable wall plate is loose

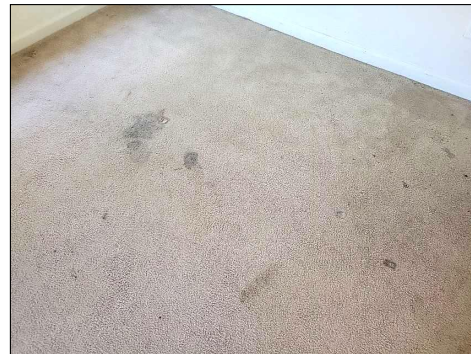
- Carpet is noted.
- Carpets were stained with normal wear and tear for age of home.

Bed #2 floor stained

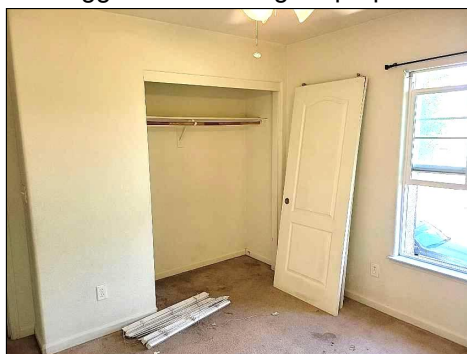
- Closets are in serviceable condition at time of inspection.
- Closet door are removed in bedroom #2. I suggest re installing for proper function of the closet.

Closet doors are off bed #2

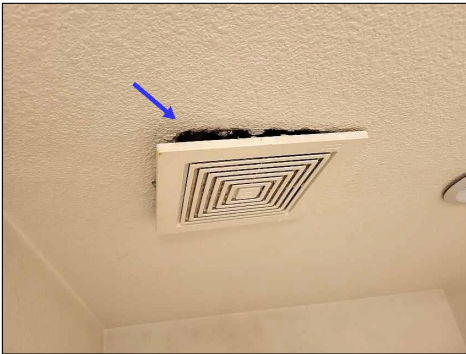
- Appeared functional, at time of inspection.
- Exhaust fan is loose at the ceiling in the upstairs guest and primary bathrooms. I suggest securing before further damage occurs.

Up stairs bath fan is loose

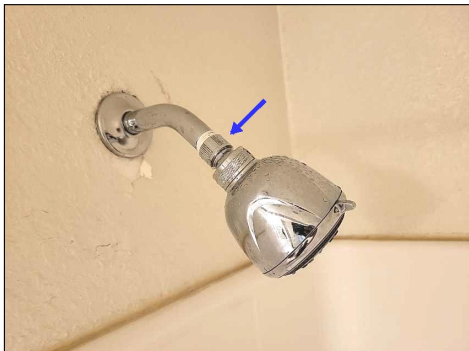
- General condition was satisfactory
- Shower(s) were functional at time of inspection
- Shower head leak at upstairs guest and primary bathrooms. The shower heads might have to be tightened more.

Shower head leak upstairs guest

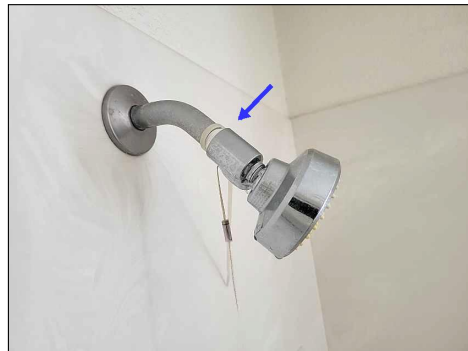
Shower head leak primary

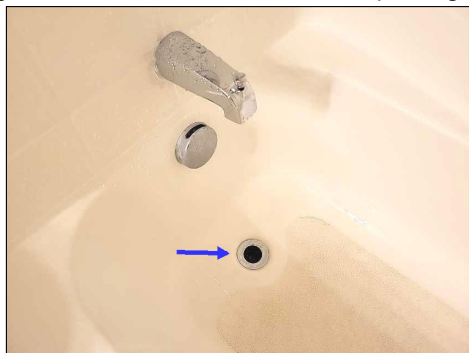
- Functional and appeared in good condition
- Missing tub stopper noted in upstairs guest bathroom. Recommend replacing to be able to retain water.

Tub stopper was missing upstairs guest

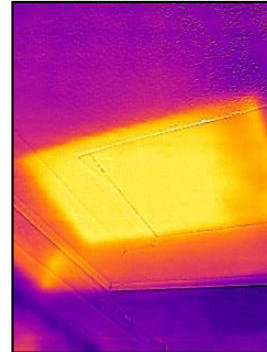
- Appeared in good general condition.
- Location of access - Upstairs ceiling
- IMPROVE: The attic access is not insulated. Expect some energy loss through convection. I suggest insulating the attic access hatch cover.

Missing insulation over access

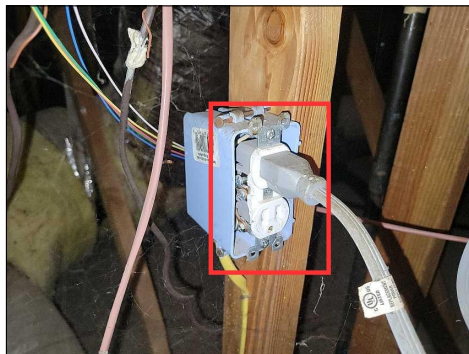
- The outlet cover is missing where the HVAC is plugged into. This is a safety issue. I recommend replacing for safety.

Outlet cover missing
