Top Notch Home Inspections

Property Inspection Report

1989 N Lion Ave , Fresno , CA 93722
Inspection prepared for: Marty McFly
Real Estate Agent: John Smith -

Date of Inspection: 6/9/2023 Time: 9 am
Age of Home: 15 Years Size: 2,126 sqft

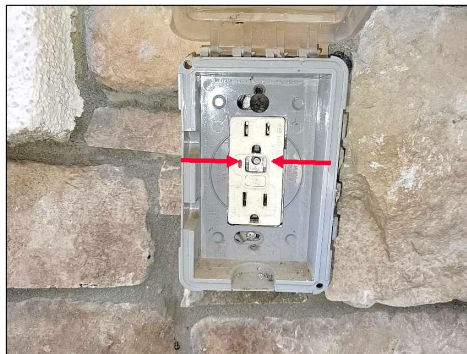
Page 10 Item: 4	Electrical, Outlets, Switches	4.2. The GFC outlet by the front door was observed as not working. The reset button is also missing. This is a defect. I recommend further review and repairs by an electrician.
-----------------	-------------------------------	---

Outlet does not work. Missing gfci tab

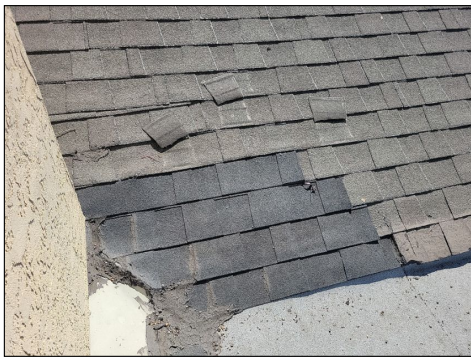
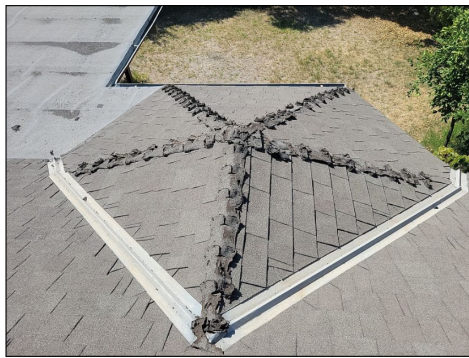
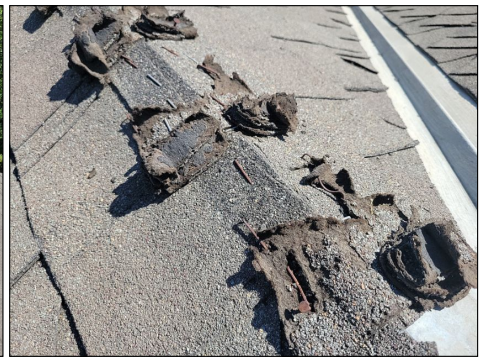
Page 12 Item: 1	Roof Condition	• Damage was observed on the roof. I recommend follow-up by a licensed roofer for further evaluation.
-----------------	----------------	---

Roof damage

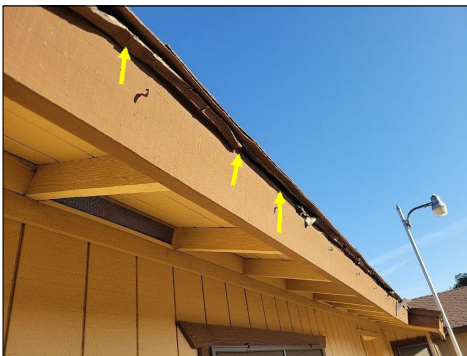
• Partial installation of **drip edge** flashing was observed with wood damage. Flashing was missing at the back of the home. Drip edge flashing prevents moisture from getting under the roofing materials and decking. If moisture were to get under the roofing material, premature failure and other damage can occur. I recommend further evaluation for possible correction by a roofing contractor.

Missing drip edge

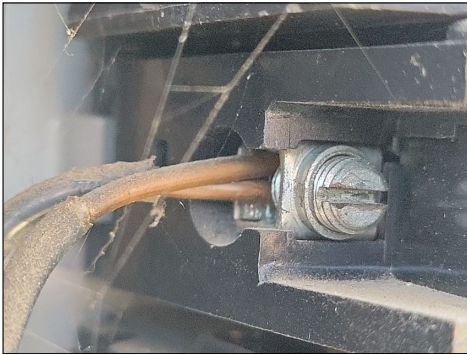
Page 15 Item: 3	Breakers & Wiring	<ul style="list-style-type: none"> • Double tapping observed. Double tapped breaker(s) inside panel box (more than one electrical conductor attached). This is not standard practice, and may cause overheating or even an electrical fire. I recommend evaluation by an electrician. Double tapping and lugging can create hot spots on breakers and neutral bars because they are not tightened to the correct torque--especially if two different size conductors are used. Because the hot [black] and neutral [white] wires are both current carrying conductors, the chance is then greater for potential hot spots. If the double tap or lug becomes loose, it begins to arc. As it arcs it builds up carbon. Carbon is then resistance and with more carbon buildup the more difficult it is for the conductor to make contact, thus increasing the current. The end result can be the breaker tripping because of the loose connection [current exceeding the rating of the breaker], or signs of overheating such as discolored wires, melted wires, etc, or even fire.

Double tap wiring

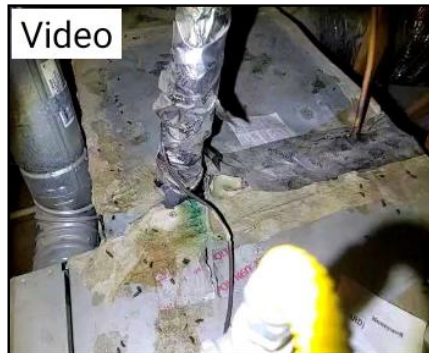
Page 16 Item: 1	HVAC Condition	<ul style="list-style-type: none"> • While running the AC an air leak was observed at the HVAC unit in the attic. Multiple types of tape were around the area indicating previous attempts at fixing an issue. I recommend further review by a HVAC contractor.
-----------------	----------------	--

Air leak

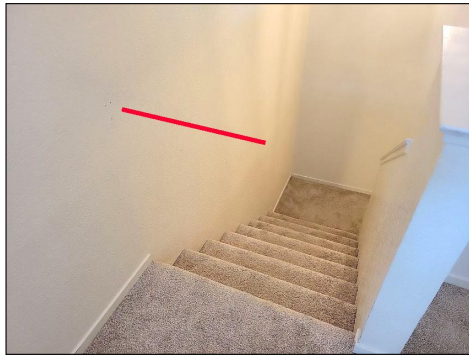
Page 21 Item: 13	Stairs & Handrail	<ul style="list-style-type: none"> • The hand rail is missing in the upper stair well of the home. This is a safety issue. I recommend further review by a contractor.
------------------	-------------------	---

Missing handrail

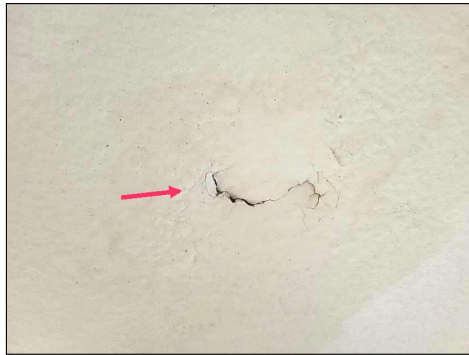
Page 22 Item: 1	Ceiling Condition	<ul style="list-style-type: none">• Evidence of past water damage with a hole was observed by the ceiling fan. Using thermal imaging, no moisture was detected at the time of inspection. I recommend further review with repairs by a contractor.
-----------------	-------------------	--

Past water damaged to ceiling in flex room

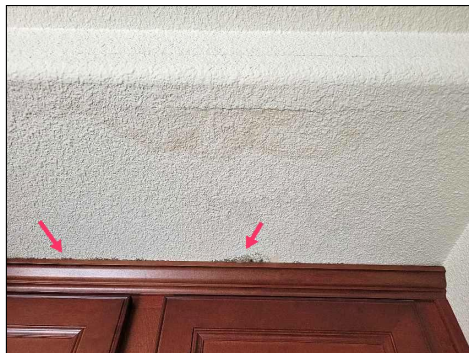
Page 23 Item: 9	Ceiling Condition	<ul style="list-style-type: none">• Fungal growth was observed at the cabinets over the refrigerator area. I recommend further review by a contractor.
-----------------	-------------------	--

Fungal growth

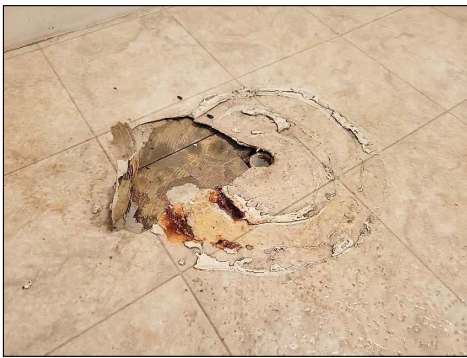
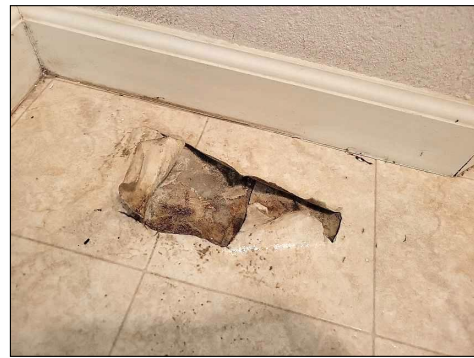
Page 25 Item: 7	Floor Condition	<ul style="list-style-type: none">• Damage was observed to the flooring.
-----------------	-----------------	--

Damage to flooring

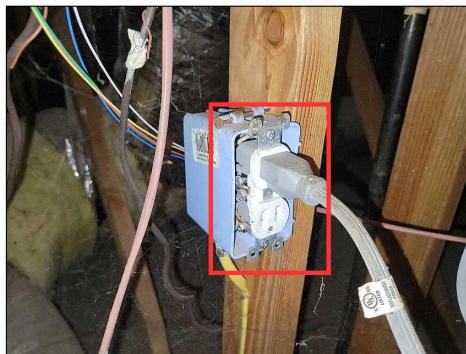
Page 32 Item: 6	Electrical	<ul style="list-style-type: none"> The outlet cover is missing where the HVAC is plugged into. This is a safety issue. I recommend replacing for safety.
-----------------	------------	---

Outlet cover missing

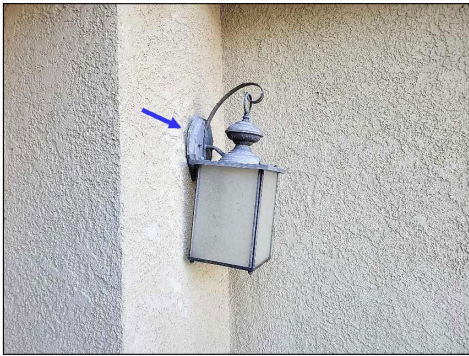
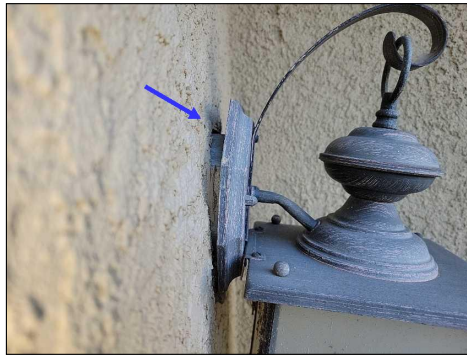
4.1. There is a gap around the front carriage light fixture. This is an access point for moisture and pest to enter through. Tightening and caulk around suggested.

Fixture separating from the wall (pic 1) Fixture separating from the wall (pic 2) Outlet does not work. Missing gfci tab

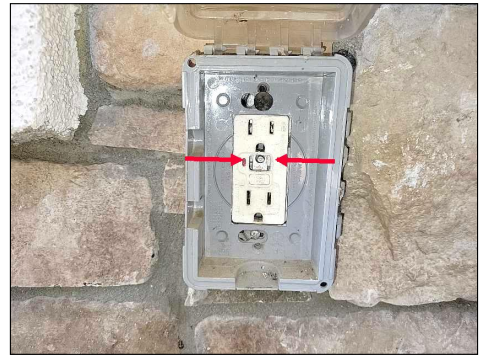
4.2. The **GFC** outlet by the front door was observed as not working. The reset button is also missing. This is a defect. I recommend further review and repairs by an electrician.

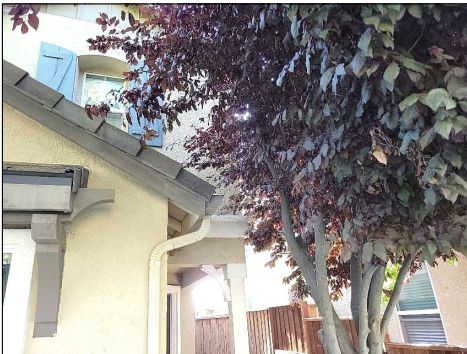
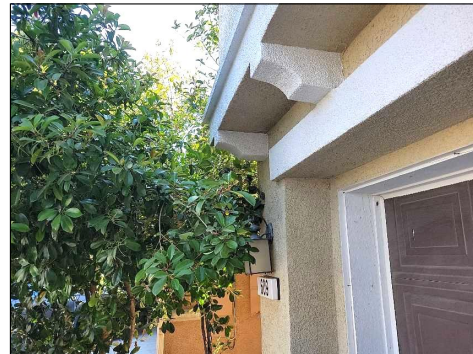
- [There is vegetation in contact with the house.](#)
- Maintenance Tip: When landscaping, keep plants, even at full growth, at least a foot (preferably 18 inches) from house siding and windows. Keep trees away from foundation and roof. Plants in contact or proximity to home can provide pathways for wood destroying insects, as well as abrade and damage siding, screens and roofs.

Vegetation in contact with the house.

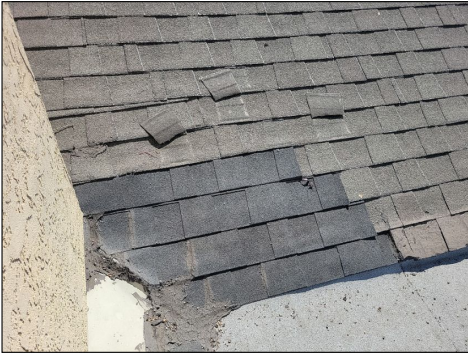
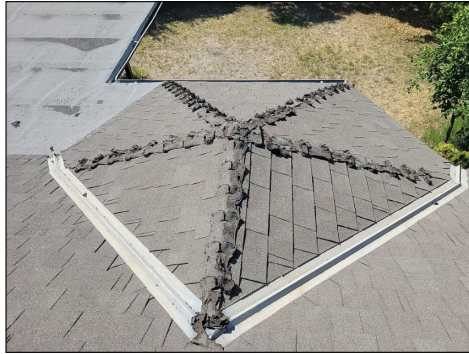
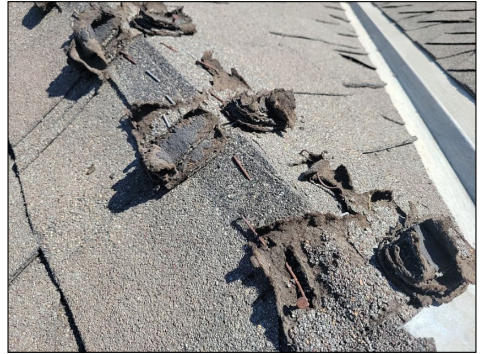
- Roof was mounted and walked on
- Asphalt shingles noted.
- **Damage was observed on the roof. I recommend follow-up by a licensed roofer for further evaluation.**

Roof damage

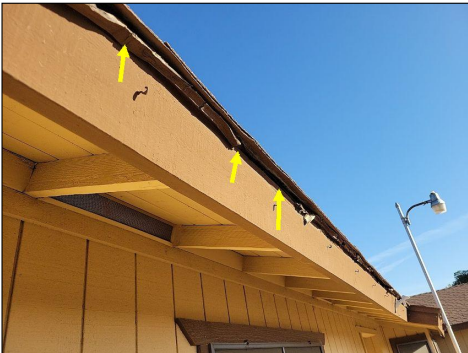
- **Kick out flashing missing. This helps divert water away for the exterior. Without this flashing water damage will occur. I recommend further review by roofing contractor.**
- **Partial installation of drip edge flashing was observed with wood damage. Flashing was missing at the back of the home. Drip edge flashing prevents moisture from getting under the roofing materials and decking. If moisture were to get under the roofing material, premature failure and other damage can occur. I recommend further evaluation for possible correction by a roofing contractor.**

Missing drip edge

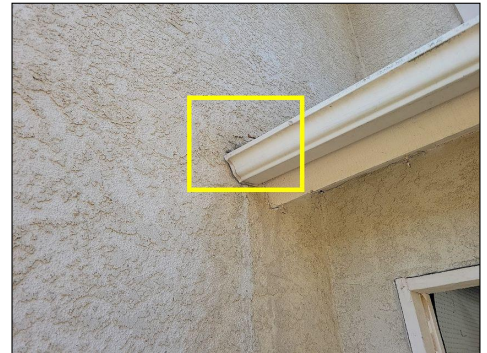
Missing kick out flashing

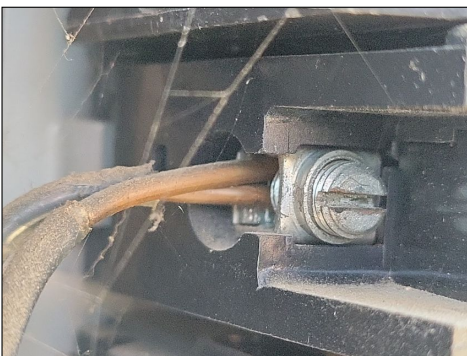
- Copper wiring noted.
- Main Amp Capacity - 200 amp
- Double tapping observed. Double tapped breaker(s) inside panel box (more than one electrical conductor attached). This is not standard practice, and may cause overheating or even an electrical fire. I recommend evaluation by an electrician. Double tapping and lugging can create hot spots on breakers and neutral bars because they are not tightened to the correct torque--especially if two different size conductors are used. Because the hot [black] and neutral [white] wires are both current carrying conductors, the chance is then greater for potential hot spots. If the **double tap** or lug becomes loose, it begins to arc. As it arcs it builds up carbon. Carbon is then resistance and with more carbon buildup the more difficult it is for the conductor to make contact, thus increasing the current. The end result can be the breaker tripping because of the loose connection [current exceeding the rating of the breaker], or signs of overheating such as discolored wires, melted wires, etc, or even fire.

Double tap wiring

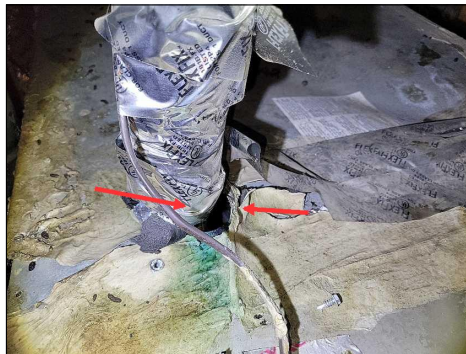
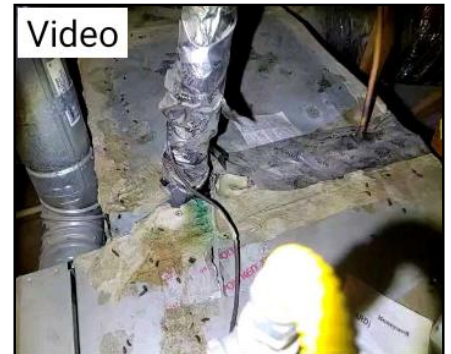
- HVAC is a split system
- Gas fired forced hot air.
- Electric
- AC compressor is located in the back yard
- Furnace is located in the attic
- At the AC condenser. The insulation cover around the refrigerant line is deteriorating and no longer useful. I suggest replacing to prevent higher cost for running the HVAC.
- Carrier Model # 24ABB342A300, 3.5 tonnage unit
- Maintenance Tip: Recommend that HVAC professional seasonally check the air conditioning unit.
- Rodent dropping were observed on the furnace in the attic. I suggest further review by a rodent inspector.
- While running the AC an air leak was observed at the HVAC unit in the attic. Multiple types of tape were around the area indicating previous attempts at fixing an issue. I recommend further review by a HVAC contractor.

Air leak

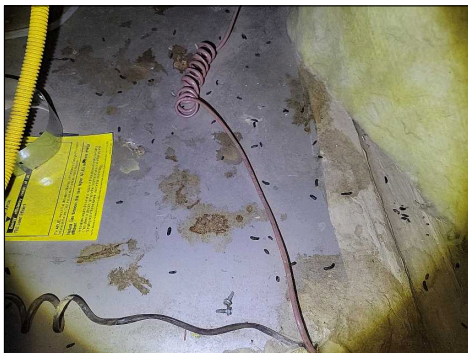
Rodent droppings

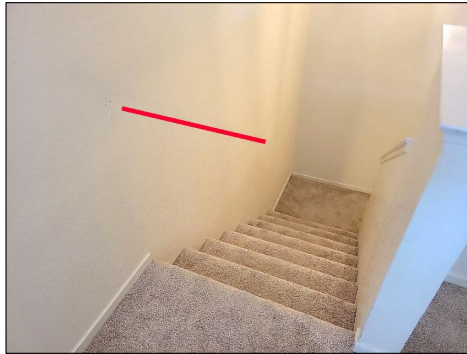
- The hand rail is missing in the upper stair well of the home. This is a safety issue. I recommend further review by a contractor.

Missing handrail

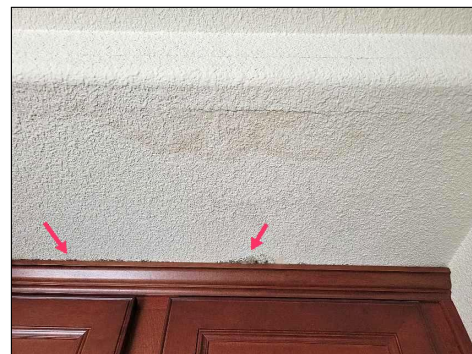
Fungal growth

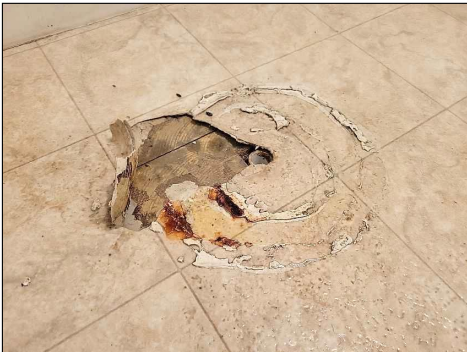
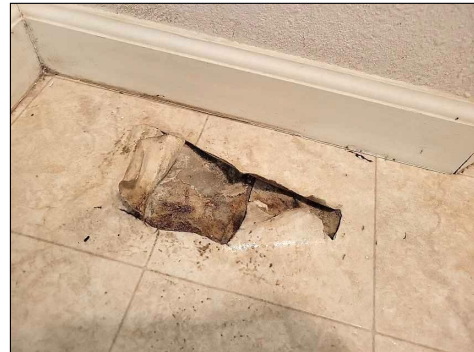
- Sheet vinyl flooring is noted.
- **Damage was observed to the flooring.**

Damage to flooring

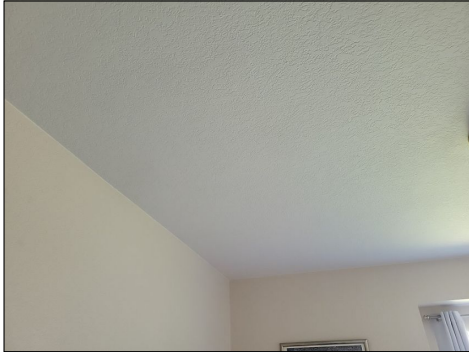
- Textured painted ceiling noted
- A heat anomaly was observed at bedroom #3 ceiling. This area is not accessible in the attic space. I was unable to locate the source of the heat. No moisture was detected. I suggest monitoring this area for any changes and contact a contractor if needed.

Heat anomaly

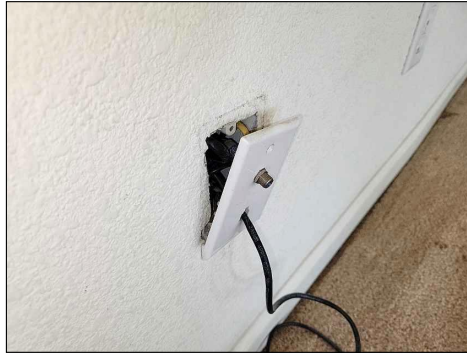
- Electrical appears to be functional and in good condition at time of inspection.
- The cable outlet was loose. I suggest re securing to prevent loss of energy in the wall space.

Cable wall plate is loose

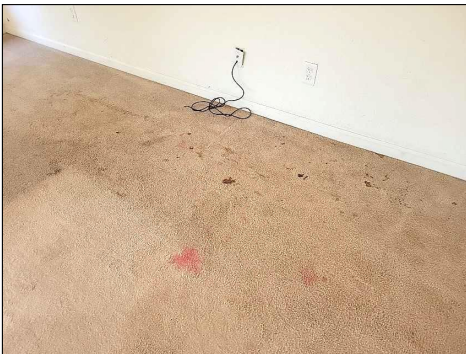
- Carpet is noted.
- Carpets were stained with normal wear and tear for age of home.

Primary carpet stained

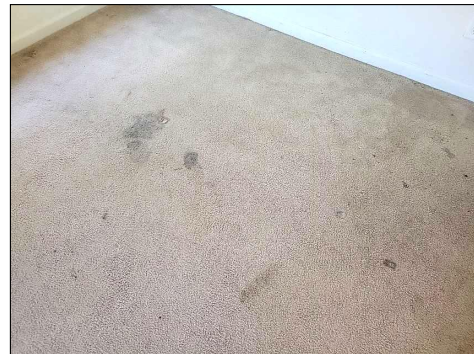
Bed #2 floor stained

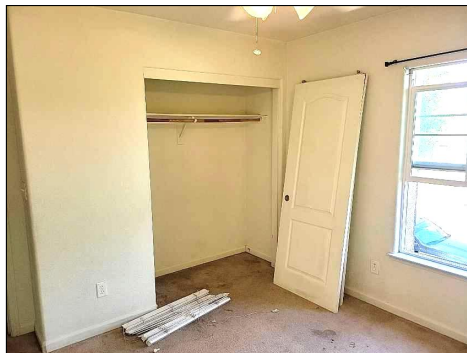
- Closets are in serviceable condition at time of inspection.
- Closet door are removed in bedroom #2. I suggest re installing for proper function of the closet.

Closet doors are off bed #2

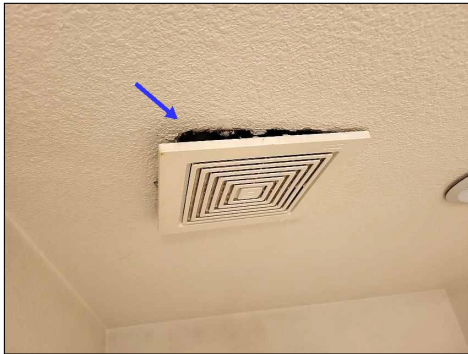
- Appeared functional, at time of inspection.
- Exhaust fan is loose at the ceiling in the upstairs guest and primary bathrooms. I suggest securing before further damage occurs.

Up stairs bath fan is loose

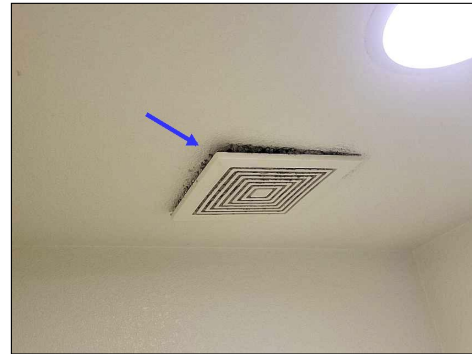
Primary bath fan is loose

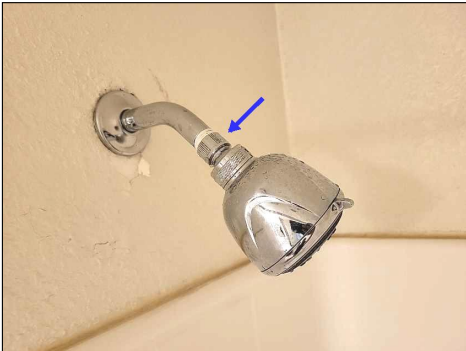
- General condition was satisfactory
- Shower(s) were functional at time of inspection
- Shower head leak at upstairs guest and primary bathrooms. The shower heads might have to be tightened more.

Shower head leak upstairs guest

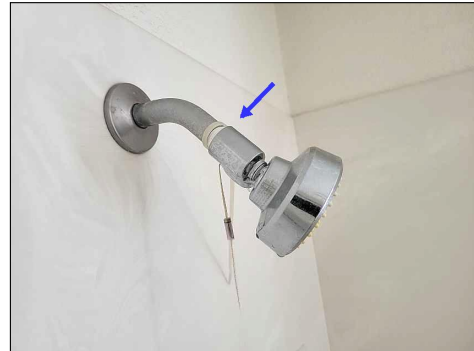
Shower head leak primary

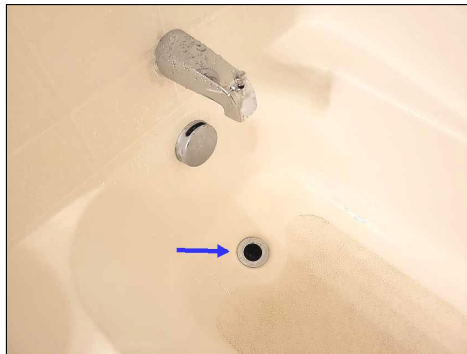
- Functional and appeared in good condition
- Missing tub stopper noted in upstairs guest bathroom. Recommend replacing to be able to retain water.

Tub stopper was missing upstairs guest

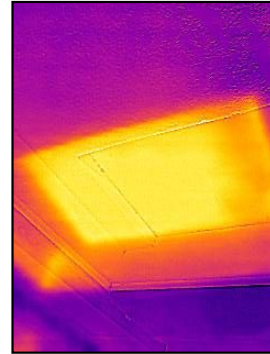
- Appeared in good general condition.
- Location of access - Upstairs ceiling
- **IMPROVE:** The attic access is not insulated. Expect some energy loss through convection. I suggest insulating the attic access hatch cover.

Missing insulation over access

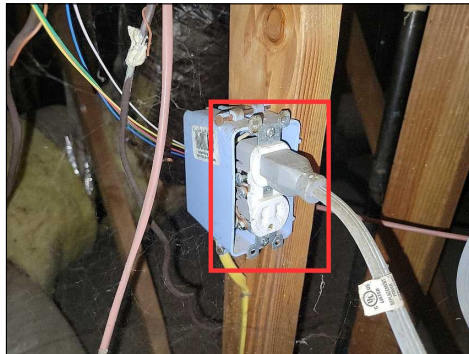
- The outlet cover is missing where the HVAC is plugged into. This is a safety issue. I recommend replacing for safety.

Outlet cover missing
