Top Notch Home Inspections

Property Inspection Report

4321 N Street Ave , Fresno , CA 93722
Inspection prepared for: Marty McFly
Real Estate Agent: John Smith -

Date of Inspection: 6/9/2023 Time: 9 am
Age of Home: 15 Years Size: 2,126 sqft

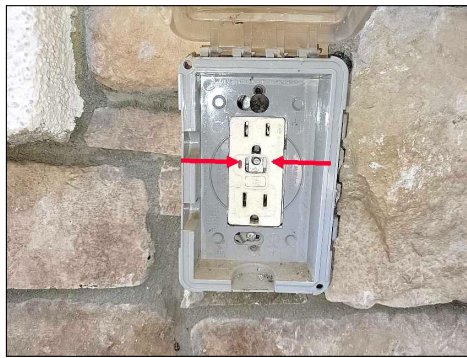
Grounds		
Page 8 Item: 4	Electrical, Outlets, Switches	4.2. The GFCI outlet by the front door was observed as not working. The reset button is also missing. This is a defect. I recommend further review and repairs by an electrician.

Outlet does not work. Missing gfci tab

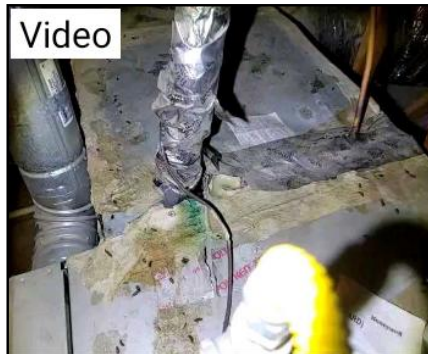
Page 13 Item: 1	HVAC Condition	1.5. While running the AC an air leak was observed at the HVAC unit in the attic. Multiple types of tape were around the area indicating previous attempts at fixing an issue. I recommend further review by a HVAC contractor.
-----------------	----------------	---

Air leak

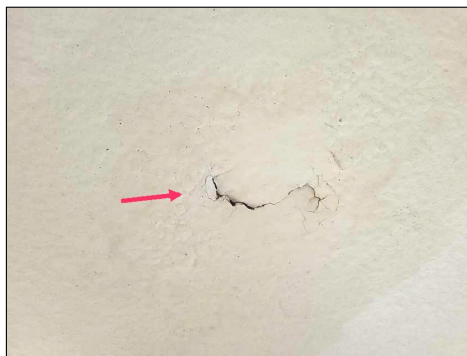
Page 19 Item: 1	Ceiling Condition	1.1. Evidence of past water damage with a hole was observed by the ceiling fan. Using thermal imaging, no moisture was detected at the time of inspection. I recommend further review with repairs by a contractor.
-----------------	-------------------	---

Past water damaged to ceiling in flex room

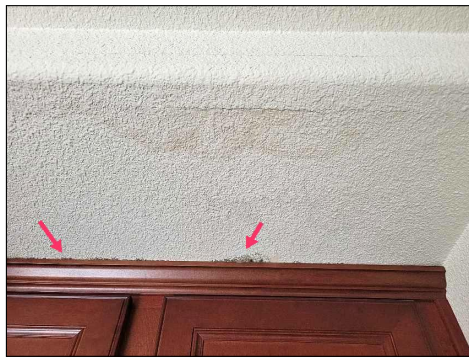
Page 20 Item: 9	Ceiling Condition	9.2. Fungal growth was observed at the cabinets over the refrigerator area. I recommend further review by a contractor.
-----------------	-------------------	---

Fungal growth

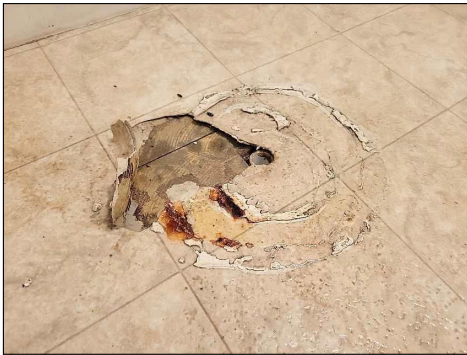
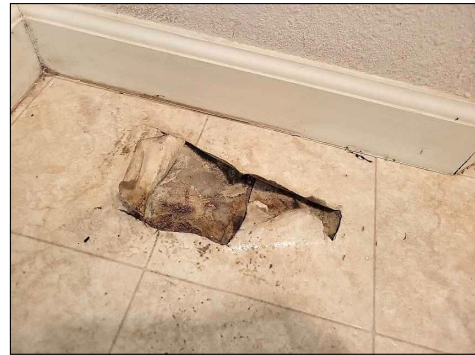
Page 22 Item: 7	Floor Condition	7.1. Damage was observed at the vinyl flooring. This most likely happened when moving the appliances. Wood flooring is visible. I recommend correction by a flooring contractor.
-----------------	-----------------	--

Damage to flooring

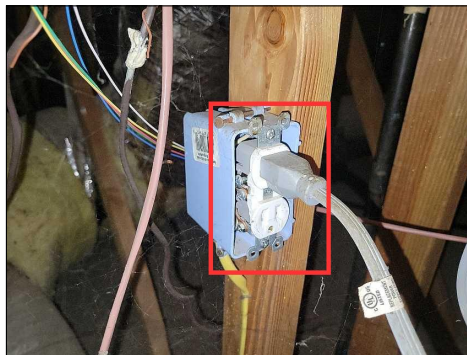
Page 30 Item: 6	Electrical	6.1. The outlet cover is missing where the HVAC is plugged into. This is a safety issue. I recommend replacing for safety.
-----------------	------------	--

Outlet cover missing

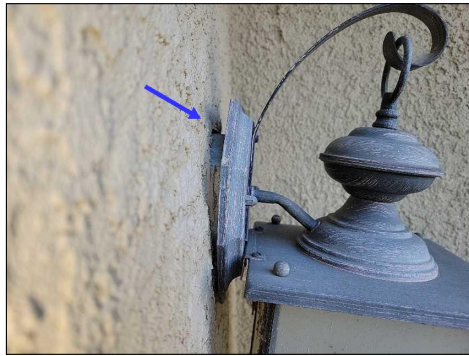
- 4.1. There is a gap around the front carriage light fixture. This is an access point for moisture and pest to enter through. Tightening and caulk around suggested.
- 4.2. The **GFC** outlet by the front door was observed as not working. The reset button is also missing. This is a defect. I recommend further review and repairs by an electrician.

Fixture separating from the wall (pic 1) Fixture separating from the wall (pic 2) Outlet does not work. Missing gfci tab

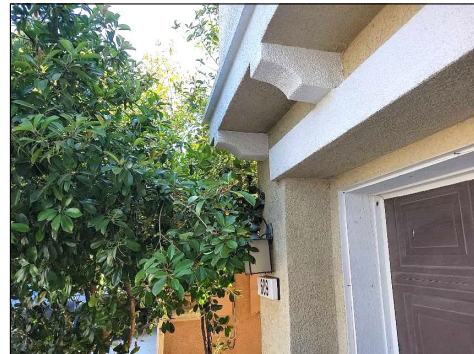
6.1. There is vegetation in contact with the house.

Vegetation in contact with the house.

6.2. Maintenance Tip: When landscaping, keep plants, even at full growth, at least a foot (preferably 18 inches) from house siding and windows. Keep trees away from foundation and roof. Plants in contact or proximity to home can provide pathways for wood destroying insects, as well as abrade and damage siding, screens and roofs.

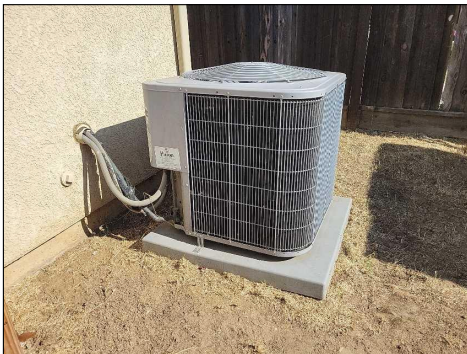
1.1. At the AC condenser. The insulation cover around the refrigerant line is deteriorating and no longer useful. I suggest replacing to prevent higher cost for running the HVAC.

AC condenser

Torn insulation cover

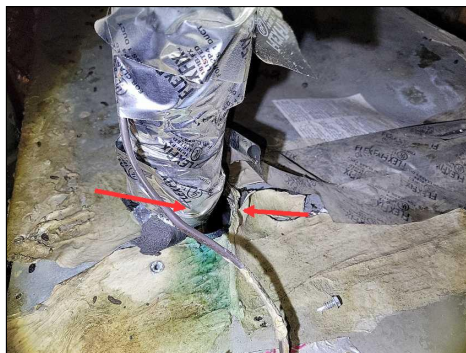
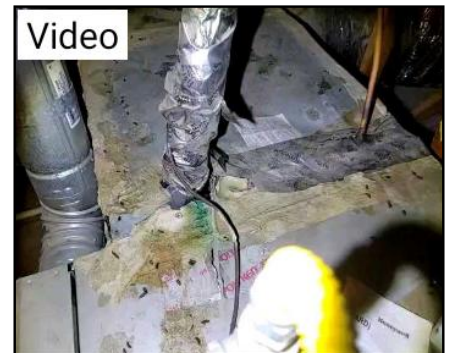
1.5. While running the AC an air leak was observed at the HVAC unit in the attic. Multiple types of tape were around the area indicating previous attempts at fixing an issue. I recommend further review by a HVAC contractor.

Air leak

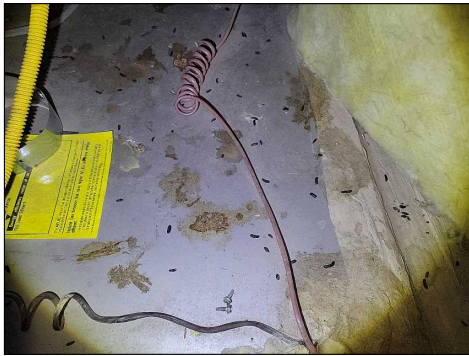
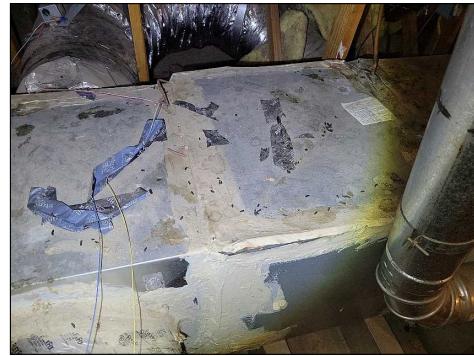
1.4. Health & Safety - Rodent dropping were observed on the furnace in the attic.

Rodent droppings

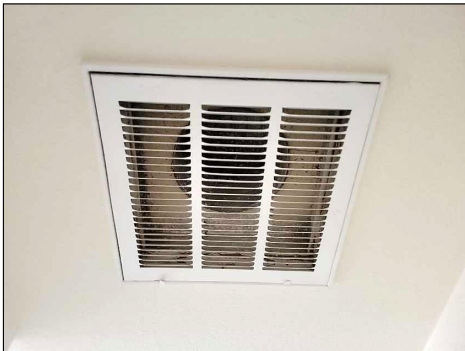
6.1. The filter is missing at the return air supply grill.

Filter is missing

6.2. Running the HVAC system without a filter can cause damage to the system. Recommend placing a filter to prevent damage.

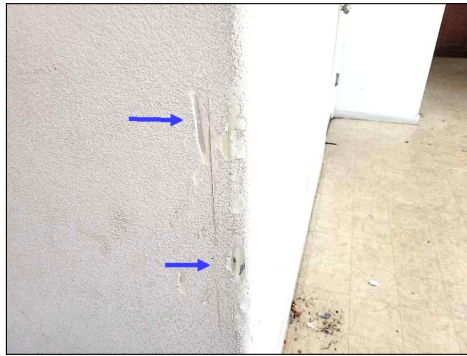
Minor damage to wall in living area

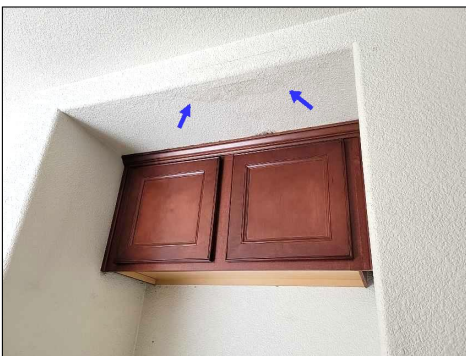
9.1. Past water damage was present to the ceiling over the refrigerator area. The primary bathroom and shower area is directly above. Using thermal imaging, no moisture was detected at the time. Monitor for any changes.

Past water damage

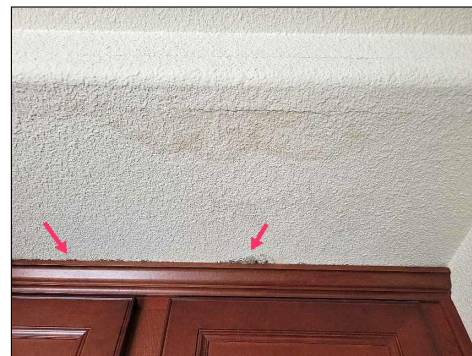
9.2. Fungal growth was observed at the cabinets over the refrigerator area. I recommend further review by a contractor.

Fungal growth

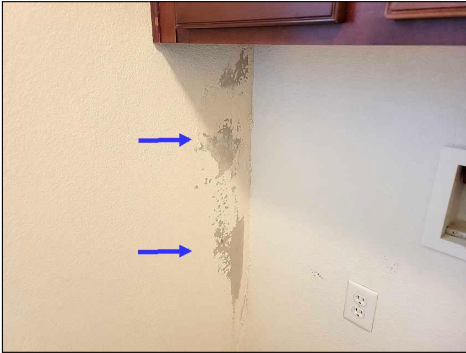
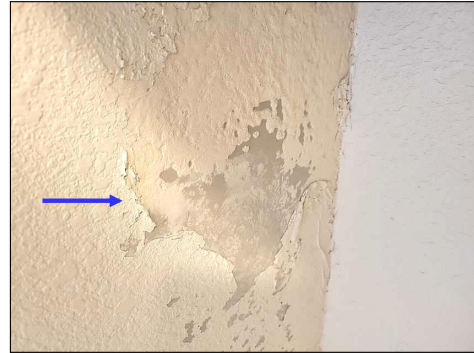
- Textured painted walls noted.
- 6.1. Wall damage was observed in the laundry room with the texture coming off.

Damage to walls

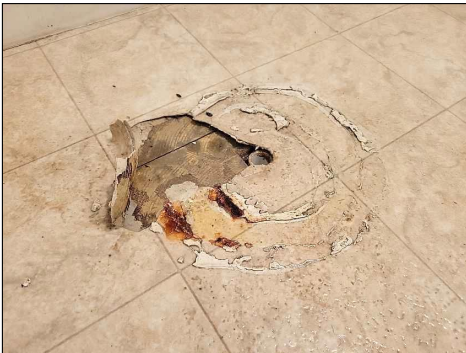
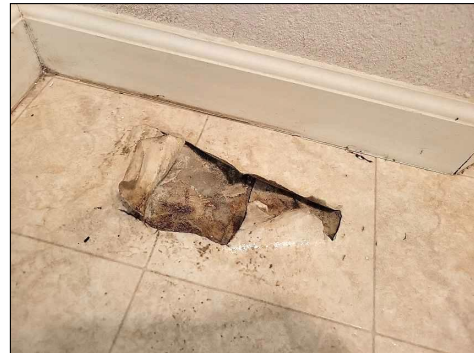
- Sheet vinyl flooring is noted.
- 7.1. Damage was observed at the vinyl flooring. This most likely happened when moving the appliances. Wood flooring is visible. I recommend correction by a flooring contractor.

Damage to flooring

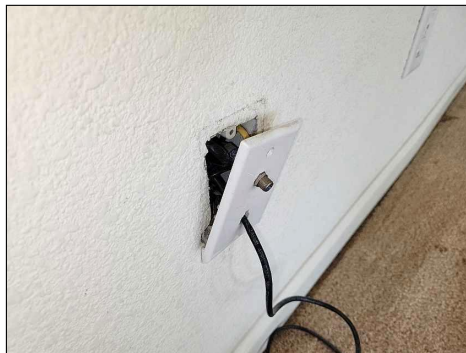
- 5.1. Electrical appears to be functional and in good condition at time of inspection.
- 5.2. The cable outlet was loose. I suggest re securing to prevent loss of energy in the wall space.

Cable wall plate is loose

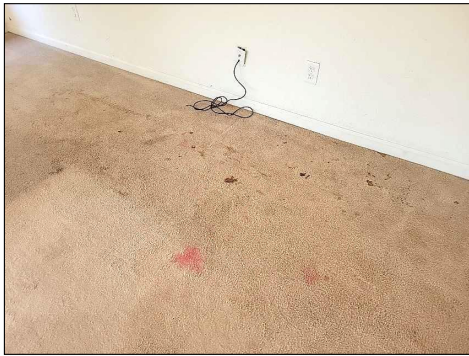
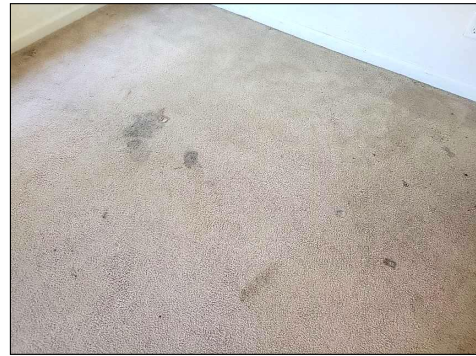
- Carpet is noted.
- 8.1. Carpets were stained with normal wear and tear for age of home.

Primary carpet stained

Bed #2 floor stained

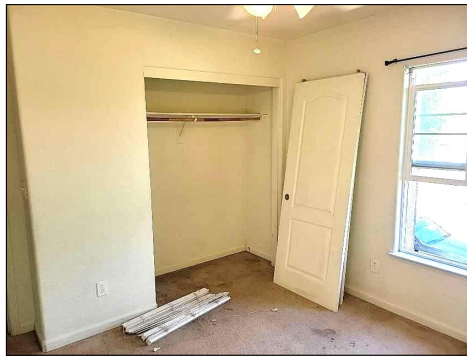
9.2. Closet door are removed in bedroom #2. I suggest re installing for proper function of the closet.

Closet doors are off bed #2

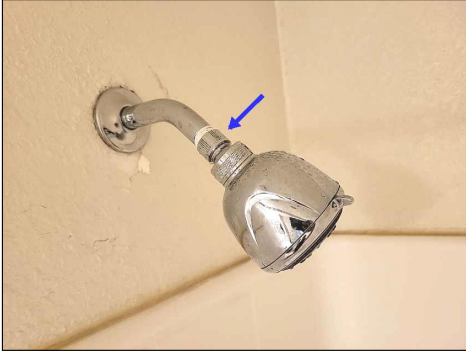
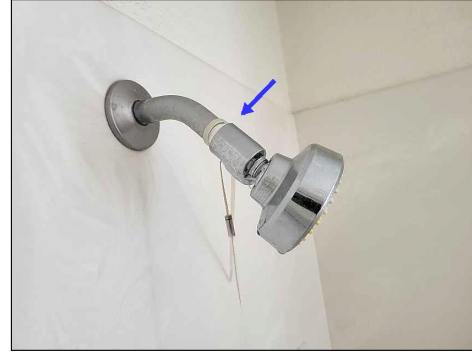
12.3. Shower head leak at upstairs guest and primary bathrooms. The shower heads might have to be tightened more.

Shower head leak upstairs guest

Shower head leak primary

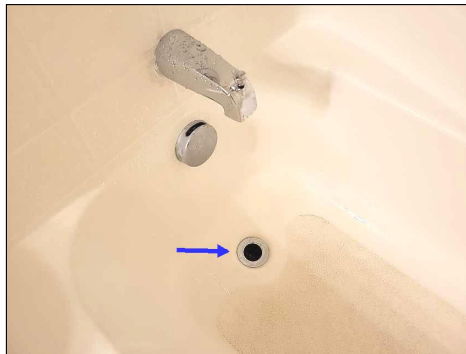
14.2. Missing tub stopper noted in upstairs guest bathroom. Recommend replacing to be able to retain water.

Tub stopper was missing upstairs guest

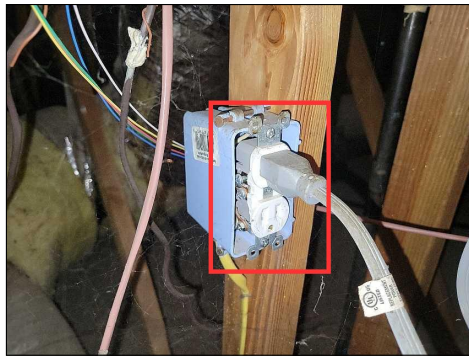
6.1. The outlet cover is missing where the HVAC is plugged into. This is a safety issue. I recommend replacing for safety.

Outlet cover missing
