Top Notch Home Inspections

Property Inspection Report

1989 N Lion Ave , Fresno , CA 93722
Inspection prepared for: Marty McFly
Real Estate Agent: John Smith -

Date of Inspection: 6/9/2023 Time: 9 am
Age of Home: 15 Years Size: 2,126 sqft

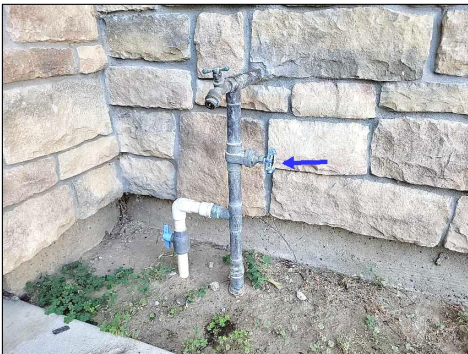
Main water shut off valve

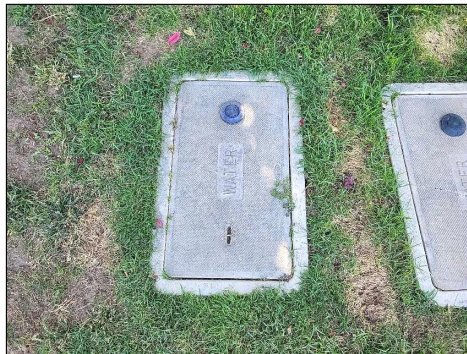
City water access at the sidewalk

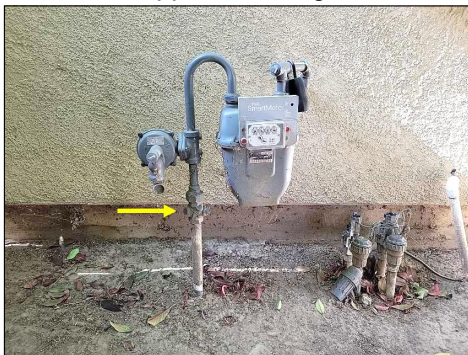
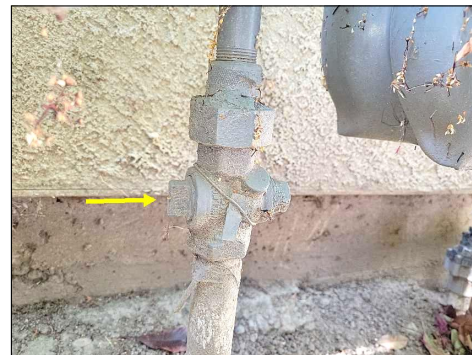
Main gas shut off valve

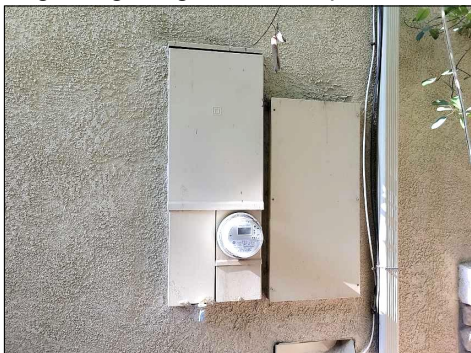
- North side of the house.
- Panel appears in good condition at time of inspection
- Main Disconnect in panel box.
- Maintenance: Sealing and caulking around the panel is recommended. This helps with keeping debris and moisture from entering and getting behind the panel.

Main electric panel

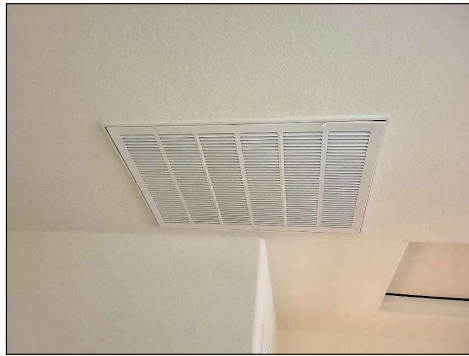
Filter up stairs hall ceiling

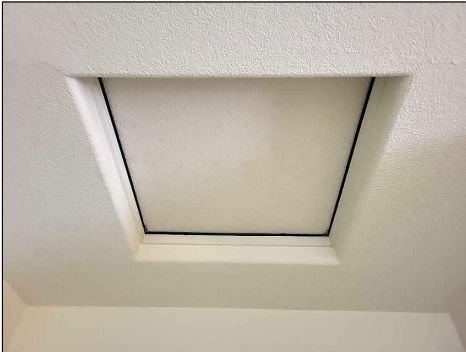
- Appeared in good general condition.
- Location of access - Upstairs ceiling
- IMPROVE: The attic access is not insulated. Expect some energy loss through convection. I suggest insulating the attic access hatch cover.

Access at up stairs hallway ceiling.

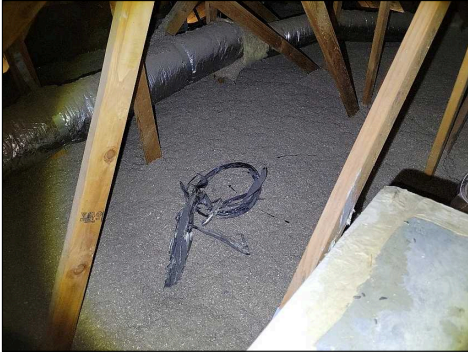
- Unfinished fiberglass batts noted.
- Loose fill insulation noted.
- Appeared adequate at time of inspection

View of insulation

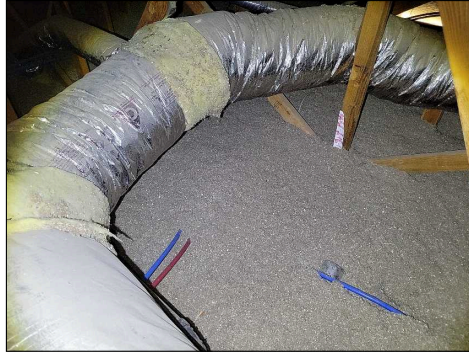
View of insulation
