Top Notch Home Inspections

Property Inspection Report

1989 N Lion Ave , Fresno , CA 93722
Inspection prepared for: Marty McFly
Real Estate Agent: John Smith -

Date of Inspection: 6/9/2023 Time: 9 am
Age of Home: 15 Years Size: 2,126 sqft

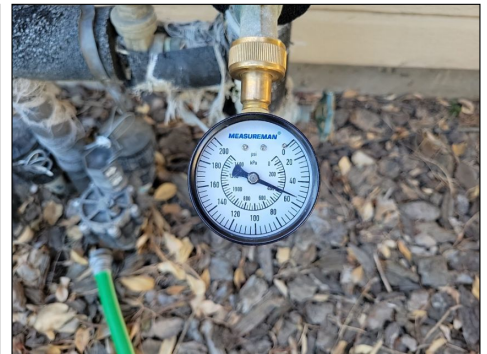
Adequate water pressure

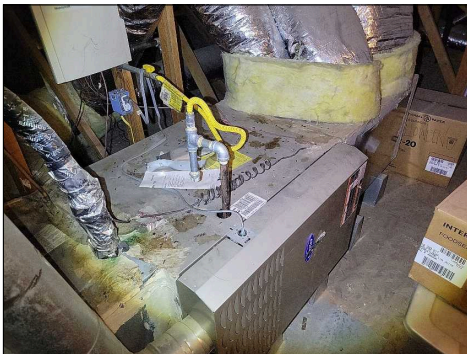
View of furnace

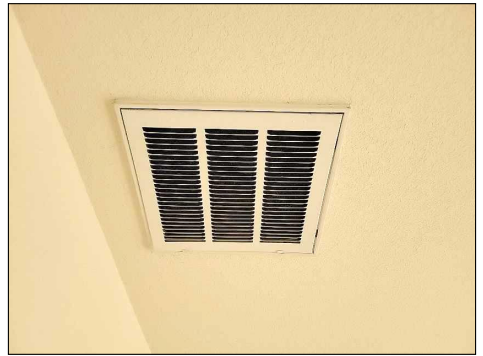
Filter location primary bedroom

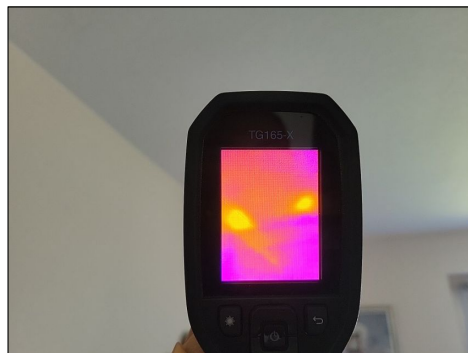
Heat anomaly
