Top Notch Home Inspections

Property Inspection Report

1989 N Lion Ave , Fresno , CA 93722
Inspection prepared for: Marty McFly
Real Estate Agent: John Smith -

Date of Inspection: 6/9/2023 Time: 9 am
Age of Home: 15 Years Size: 2,126 sqft

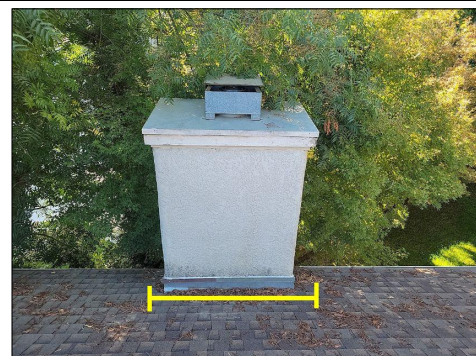
• Missing cricket. If the chimney has a dimension parallel to the ridge line greater than 30 inches and does not intersect the ridge line, a chimney cricket should be provided. I recommend further review by a roofer or chimney contractor.

No cricket flashing present

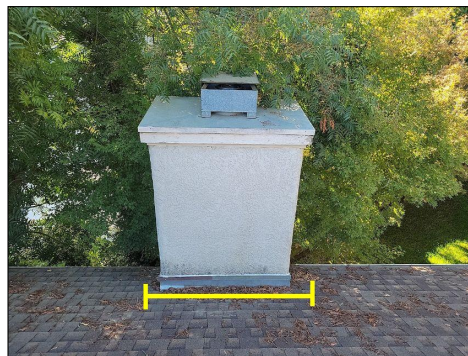
- Missing cricket. If the chimney has a dimension parallel to the ridge line greater than 30 inches and does not intersect the ridge line, a chimney cricket should be provided. I recommend further review by a roofer or chimney contractor.

No cricket flashing present

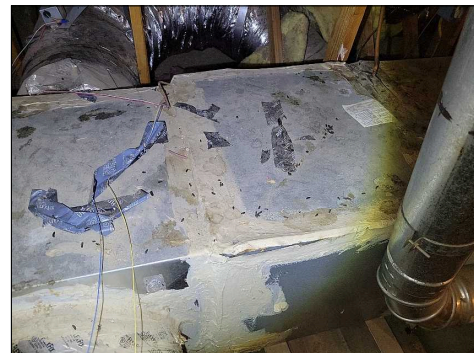
Rodent droppings

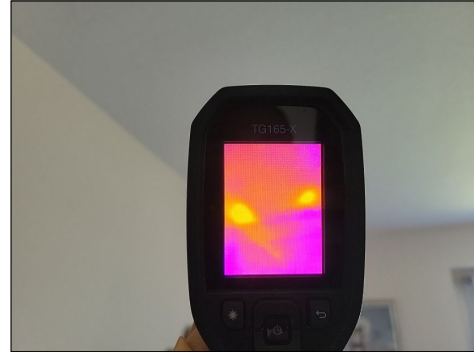
Heat anomaly

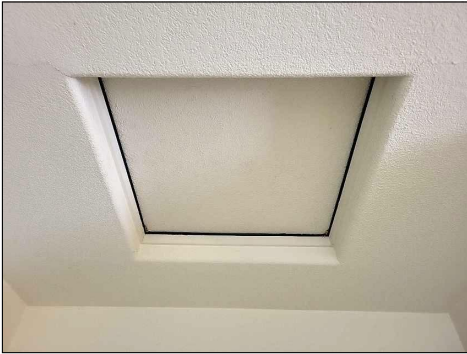
- Appeared in good general condition.
- Location of access - Upstairs ceiling
- **IMPROVE:** The attic access is not insulated. Expect some energy loss through convection. I suggest insulating the attic access hatch cover.

Access at up stairs hallway ceiling.

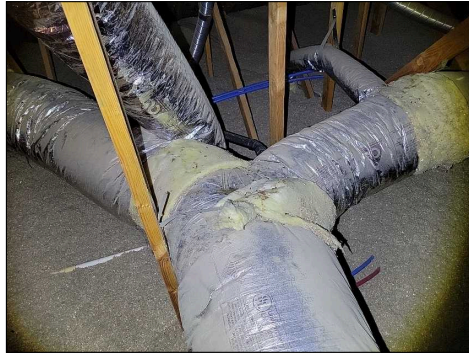
View of ducting

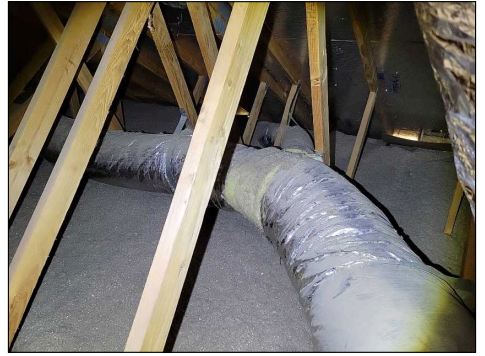
View of ducting

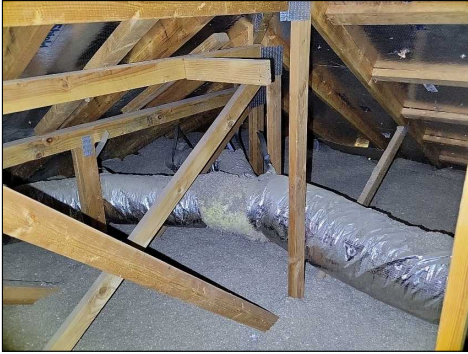
View of ducting

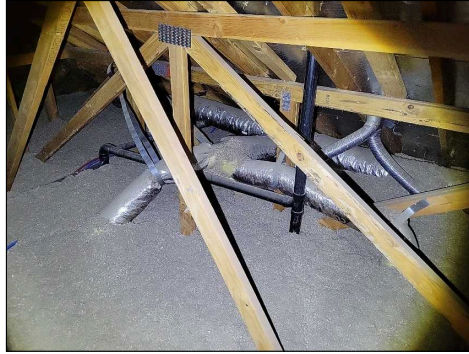
View of ducting

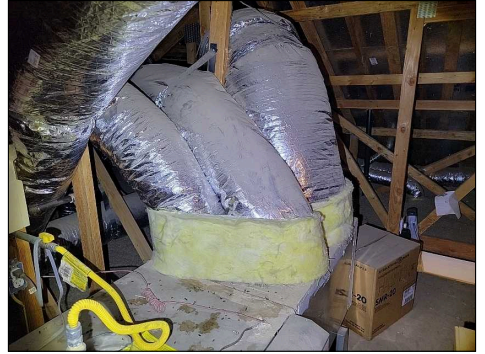
View of ducting

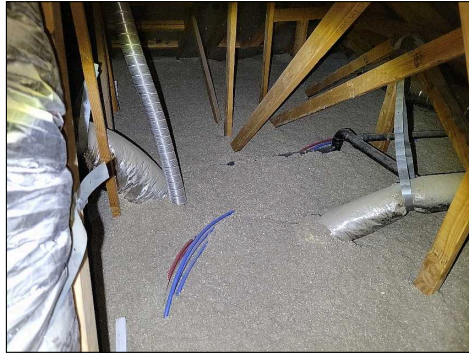
View of insulation
